DEAN VALLEY WALKWAY : First Phase Feasibility Study
for Dean Valley Regeneration Limited

Elizabeth Dorrian Landscape Architect

Final Report August 2017

WALL SURVEY 17th January – 6th February 2017

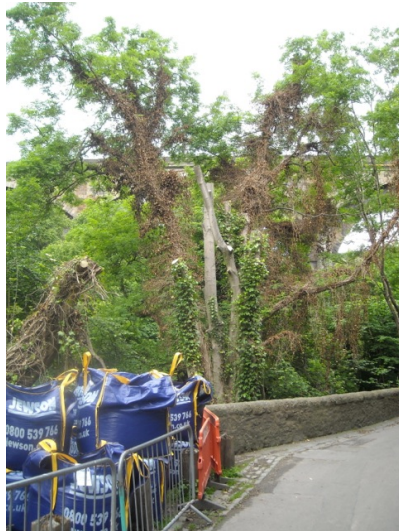
In addition, and since this visit with CEC, tree works have been carried out at the Dean Village end of the path, with ash trees severely cut. A damaged wall, noted for repair in this document, has also recently been pointed, apparently with cement and not lime mortar.

Tree cutting carried out near Lindsay's Mill since this survey
(Photo June 16th 2017)

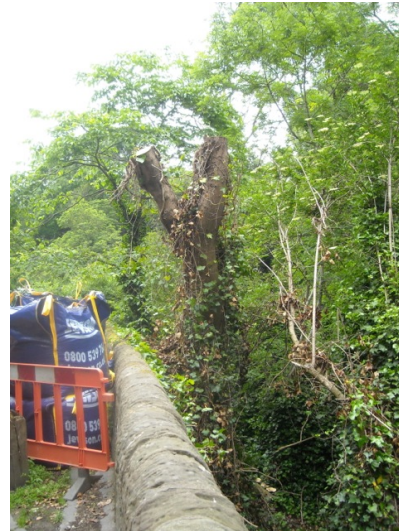
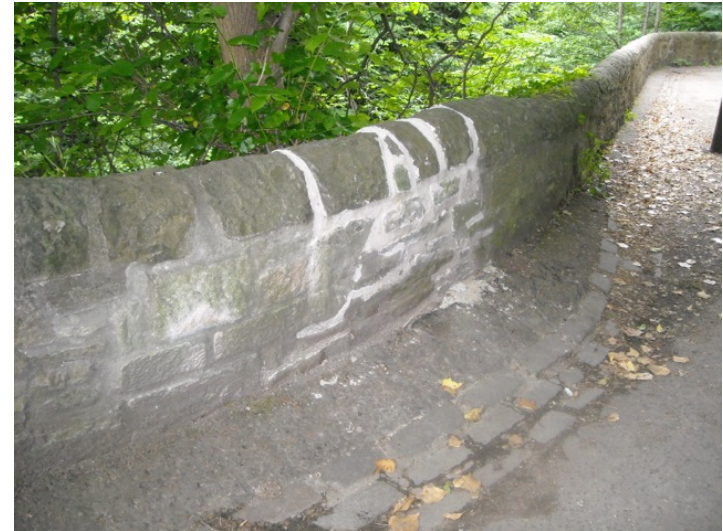
Wall repair carried out since this survey
(Photo June 16th 2017)

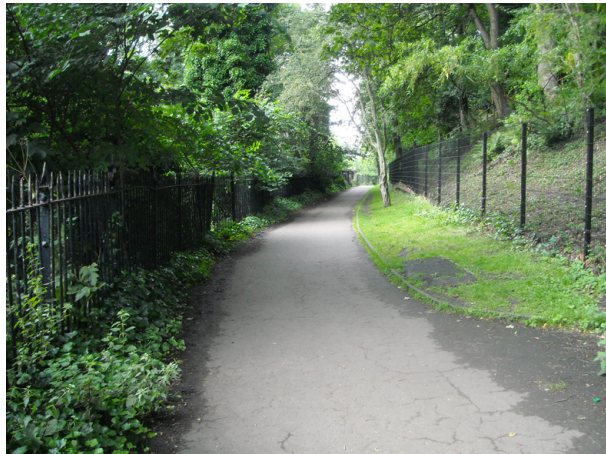
Grass verge to main path at St Bernard's Well

The only opportunity to widen the main path is in the location of St Bernard's Well where there is a grass verge on the side adjacent to the gardens (ref photo on previous page). It is advised however that the visual amenity of having a grass verge here outweighs the physical benefits of widening the path (which is still within the minimum recommendation) albeit that the grass suffers from overrun.

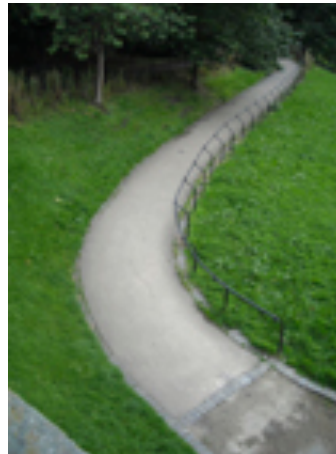
Link path

The walkway currently meets the recommended minimum 3m width of a shared route along most of its length and averages 3.2m. The section where it is less than 3m is on the newest section of path linking upper and lower routes at St Bernard's Bridge. Here it is 2m, made to feel narrower by the inward curve of the railing. This link offers the barrier-free route to connect the path with Stockbridge and in this capacity has to be shared.

With regard to the link path currently narrower than 3m – the least intrusive means of widening this section would be to re-position the handrail so that it sits approximately 300mm further from the path edge. The curve on the top rail means it would still function effectively, but it would physically increase the width of the pathway to some degree. With this option no increase on the actual surfacing would be necessary, simply a footing at each post. If the path were to be widened to 3m it would be a significant operation and the path would begin to look out of proportion at this location. Having a restricted width could be regarded as a benefit by reducing speeds on this sloped section of the path.

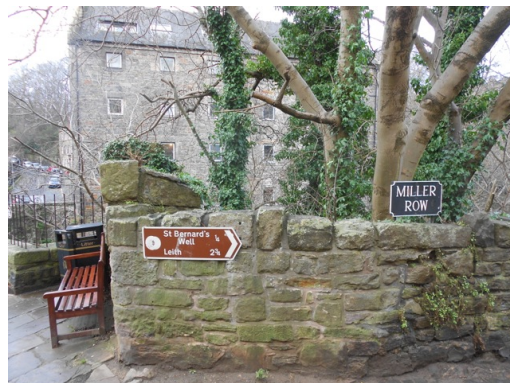
Existing sign at Dean Village access – no reference to cycle use

The main need for improved signing appears to be to make it clear that the path is for shared use by both pedestrians and cyclists. Simple signing at access points in the same style as other city-wide cycle/path route signing should be introduced (Directional Signs) and additional signing (Information Signs) along the route should be placed as reminders that the route is shared and for cyclists to use a bell as well as warning of icy winter conditions. Refer to Plan in **Appendix Seven**.

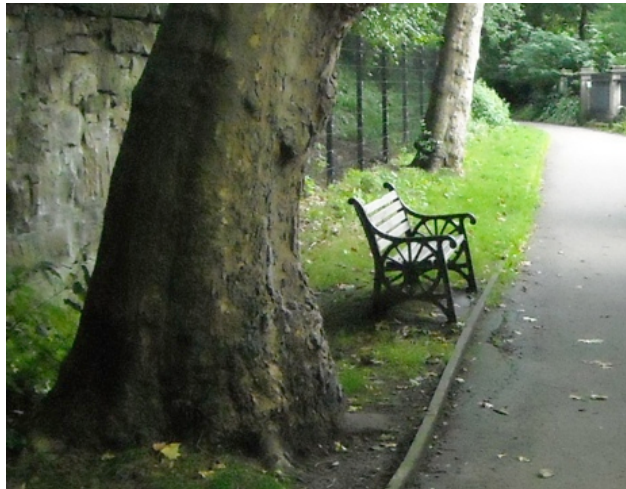
Bench on upper path

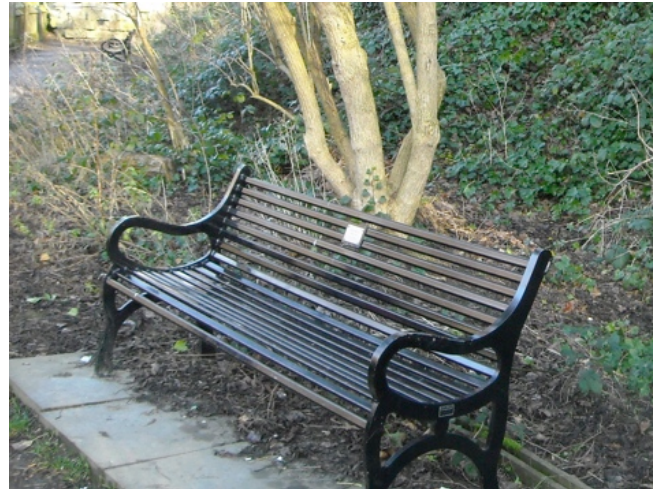
There are two different styles of bench in use. The standard Council-favoured style is located on the lower level by St Bernard's Well and when this area is looked at in more detail (recommendations in the Conservation Statement are for this area to be restored to the layout of 1888) the style of bench should be re-considered.

Standard Council-style bench on lower path

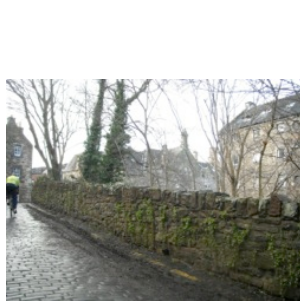
Ref. No	Comments	Proposals
W1	Max 1.45m high. Patchy pointing. Live tree stumps damaging top of wall	Remove cope, clear stumps, replace cope and re-point east face of wall - approx 24 lm
W2	Part of Lindsay's Mill, not included in survey.	-
W3	Part of Lindsay's Mill, not included in survey.	-
W4	Part of Lindsay's Mill, not included in survey but live tree stumps still in wall.	-
W5	42m of wall .85m- 1.1m high with rounded cope.	Re-point 9.5 lm within overall length
W6	12m of av. 1.1m high wall with rounded cope covered by vigorous ivy	Remove ivy and re-point as necessary
W7	Wall .8m high lifted and damaged by adjacent tree.	Re-build 5m length
W8	Wall .94m high lifted and damaged by adjacent tree.	Re-build 2m length
W9	Wall 1.03m highlifted and damaged by adjacent tree.	Re-build 3.5m
W10	Wall 1.15m high lifted and damaged by adjacent tree & generally poor pointing	Re-build 2m length and re-point along 35 lm
